# LEVEL 2 HOME SURVEY

REPORT PREPARED IN ACCORDANCE WITH THE  
RICS HOME SURVEY STANDARD

**Sample Road, Harrow, HA1 1AH**

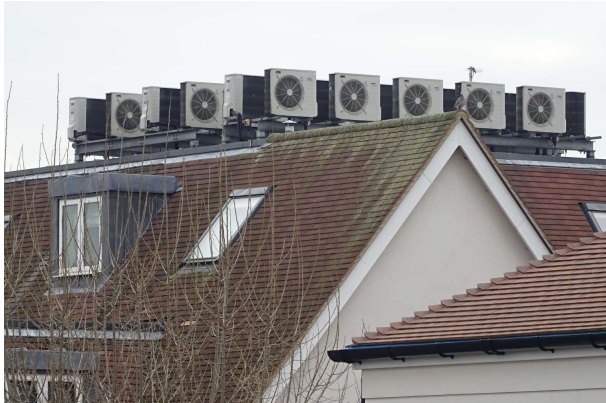
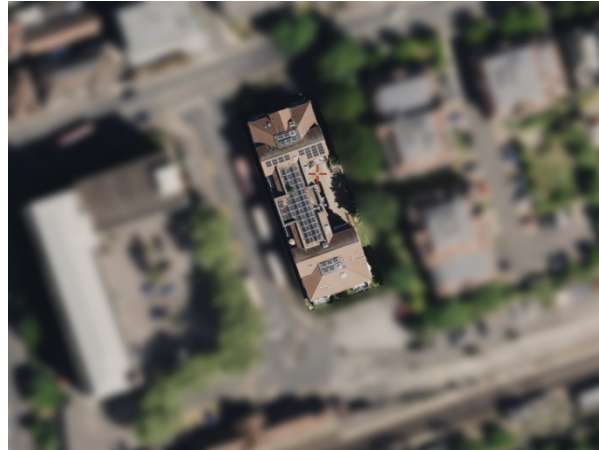
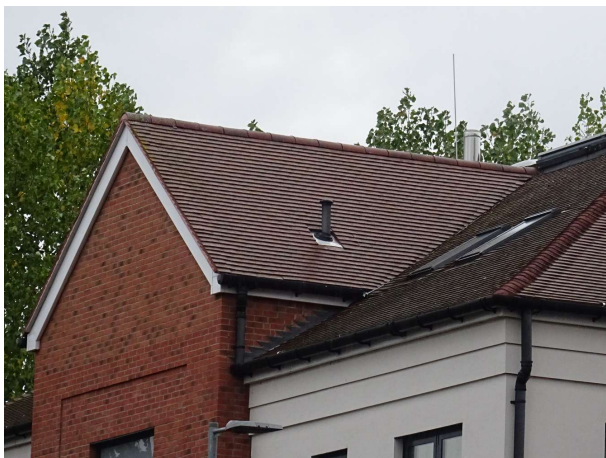
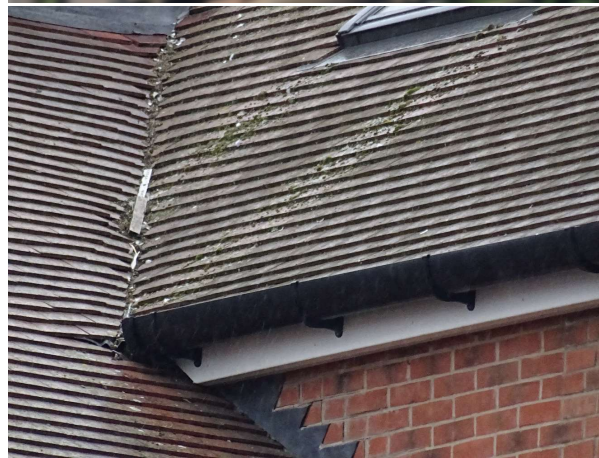
There are sloping valley gutters to parts of the property where the roof slopes meet. One of the front valleys was partially blocked with debris and moss and will require clearing to ensure effective roof drainage, as a blockage can lead to moisture ingress into the building.

Some moss and lichen growth was noted on the north-facing roof slopes, though not to any concerning extent at the time of the survey. If left unchecked, moss and lichen can block gutters, degrade roof coverings and negatively affect the appearance of the property. Periodic removal from the roof coverings and rainwater goods should be anticipated to maintain performance and prolong the roof's life expectancy.

Ask your legal adviser to clarify your repair liability under the lease during conveyancing.

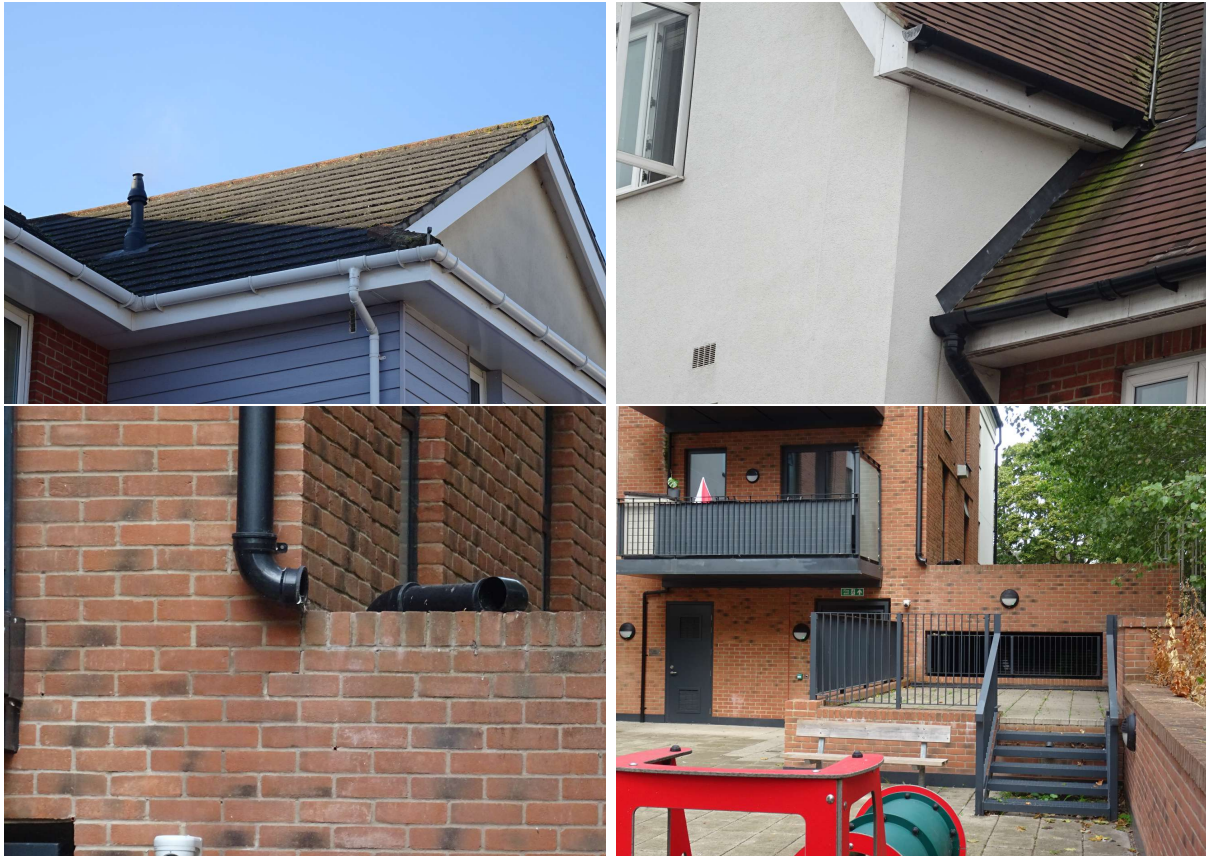
We noted defects, including a loose and disconnected section of downpipe at the rear of the block, with staining to the adjacent external brickwork. This can deteriorate the surrounding masonry and cause moisture-related damage to nearby components. Repair and maintenance works are now required to reduce the risk of penetrating dampness.

Report the defective downpipe at the rear of the building to the management company for inclusion in the building's maintenance programme.

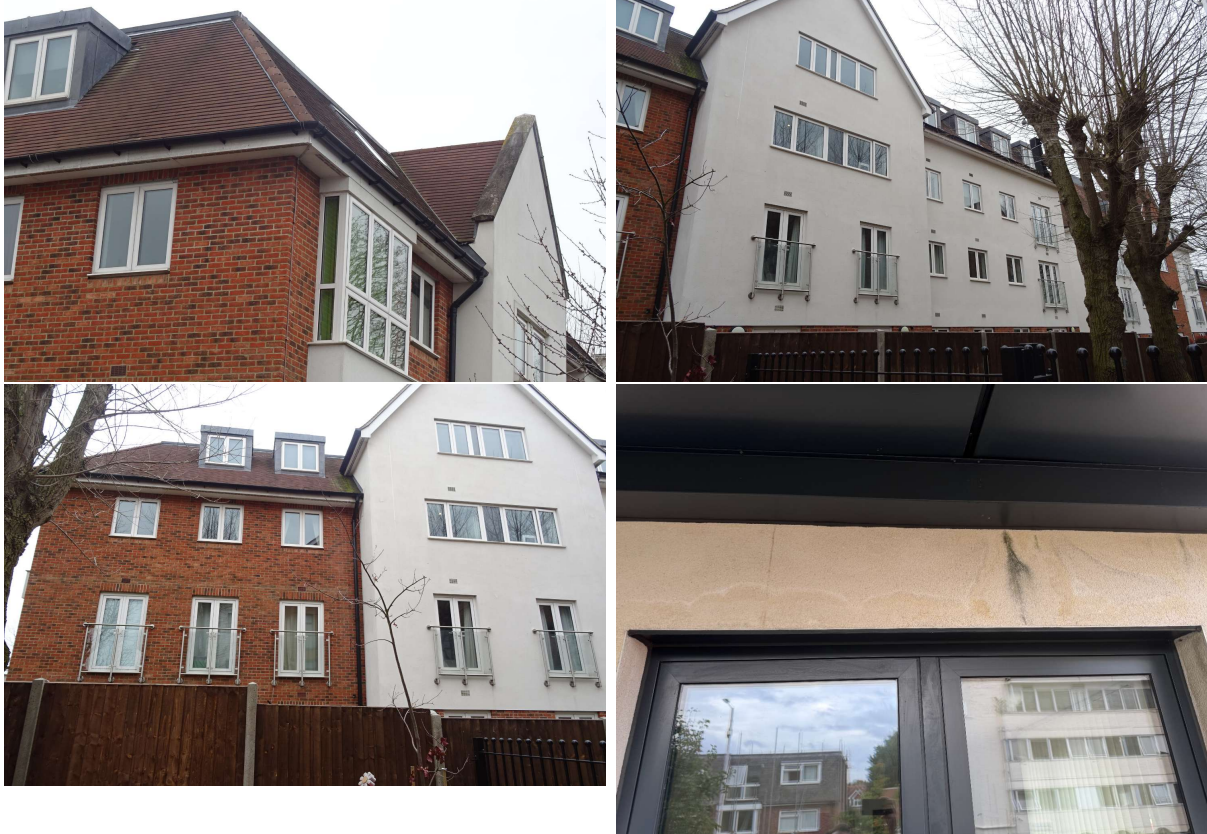
Localised staining, together with areas of green algae growth and vertical run-off staining, was noted on the rendered wall surface below the second-floor balcony serving the flat above. The staining pattern suggests repeated moisture run-off from the balcony above or associated rainwater disposal arrangements. At the time of inspection, no significant cracking, detachment, or deterioration of the render finish was evident; however, prolonged wetting may lead to deterioration and increased maintenance requirements if left unresolved. The mastic seal visible to the underside of the balcony junction appeared complete and intact at the time of inspection, so previous maintenance works may have been undertaken in this area. No internal water ingress was observed during the

Notify the management company of the staining beneath the second-floor balcony and request that the source of the moisture, including the balcony junction and associated external detailing above, be investigated and any necessary repairs carried out. Following repair, monitor the area after rainfall for further staining, algae growth, render deterioration or water ingress.
