# LEVEL 3 BUILDING SURVEY

REPORT PREPARED IN ACCORDANCE WITH THE  
RICS HOME SURVEY STANDARD

Property address:  
**Sample Street, Harrow, HA1 1AH**

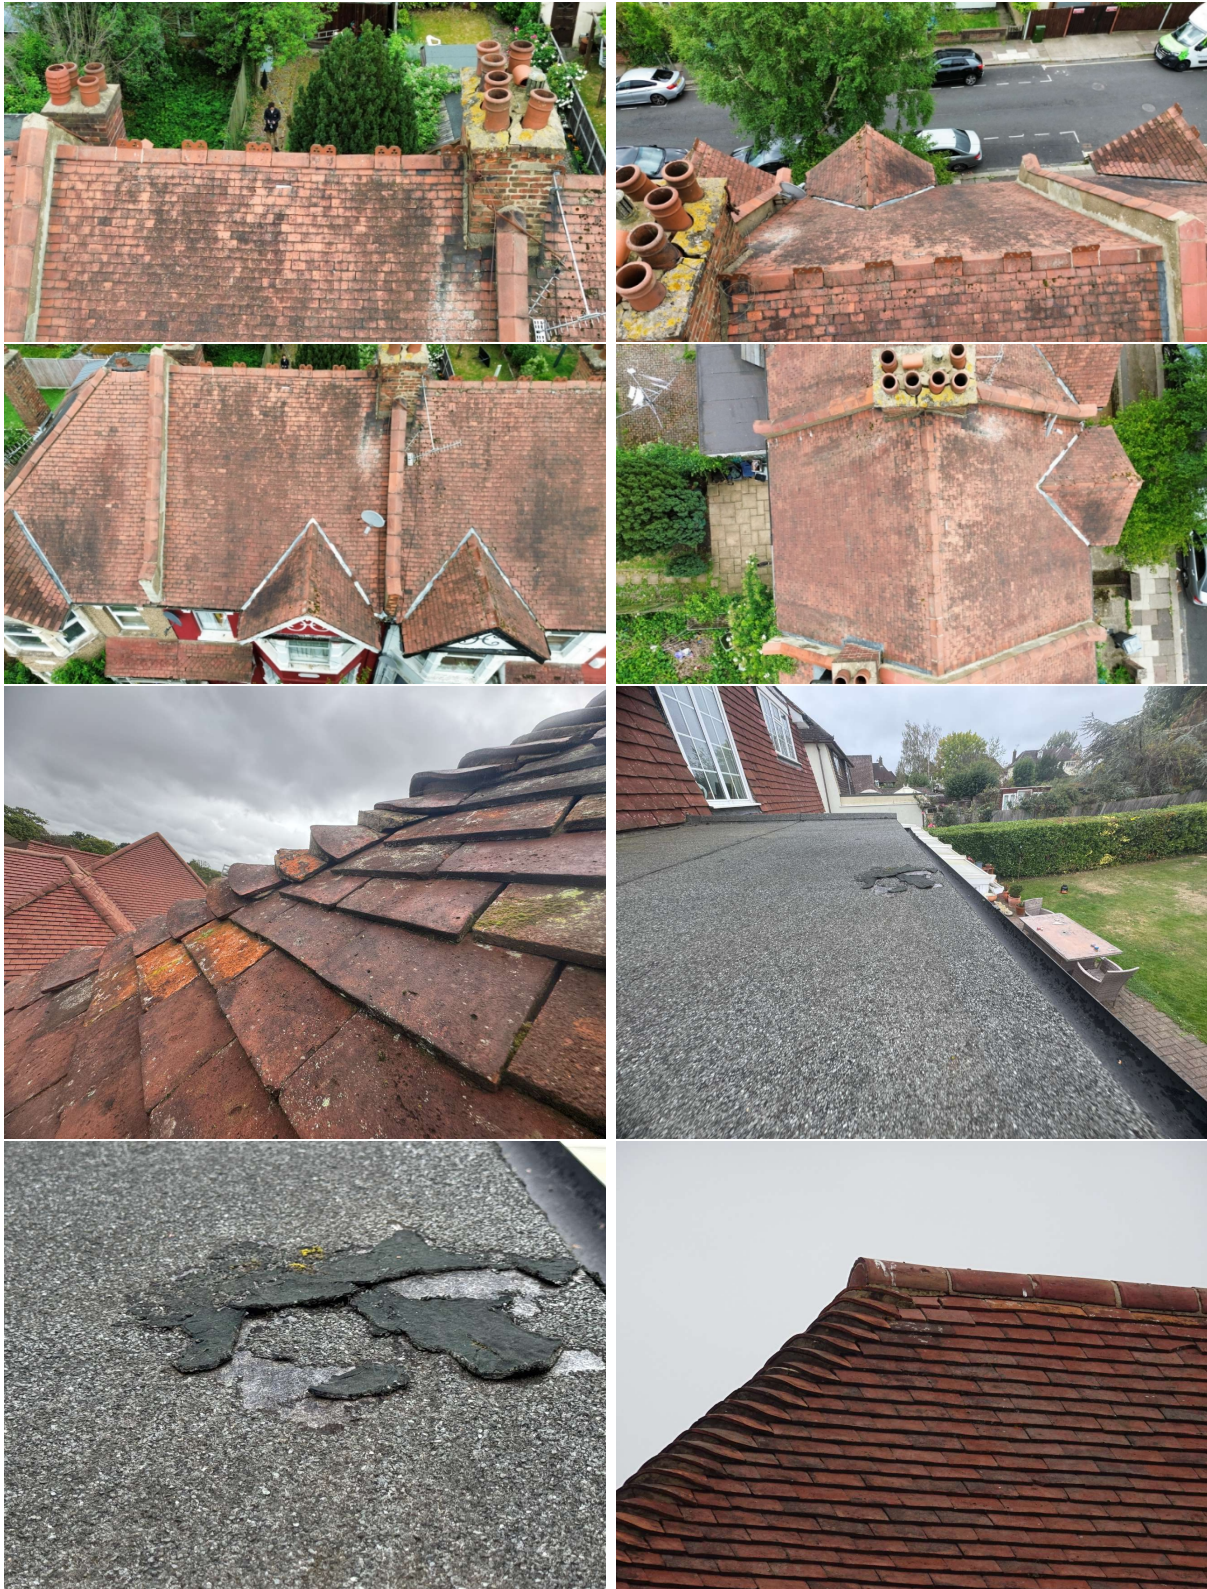
Pitched roof: Elevated moisture meter readings and a peeling paper finish to the ceiling were recorded in the first-floor bay-fronted bedroom, near the redundant chimney breast. This indicates an active leak, most likely through the right-hand roof slope (as viewed from the front). The precise point of entry could not be determined from ground level by non-intrusive inspection. Condition Rating 3 has been applied because the defect needs prompt investigation and repair by a roofing contractor.

Isolated areas of cracked and deteriorated mortar bedding were noted to the hip tiles, together with a small number of cracked, chipped and slipped roof tiles. These defects may allow water ingress and should be rectified. The deteriorating mortar bedding may also result in hip tile dislodgement, particularly during strong winds, and provide potential entry points for moisture and insects into the roof void. A roofing contractor should replace the missing or damaged tiles and renew the defective mortar bedding as necessary.

Flat roof: The flat roof covering over the kitchen extension has a damaged section where the upper layer of mineral-coated felt has cracked, peeled and deteriorated, exposing the base layer beneath. The remaining flat roof surface appears to be serviceable.

Inspect the roof thoroughly at least once a year, ideally in spring, to identify winter damage before minor defects develop into leaks and decay. It should be checked after storms for slipped, broken or missing tiles. Routine maintenance should include removing moss and lichen, replacing damaged tiles and repairing deteriorated mortar bedding to keep the roof weathertight and extend its life.

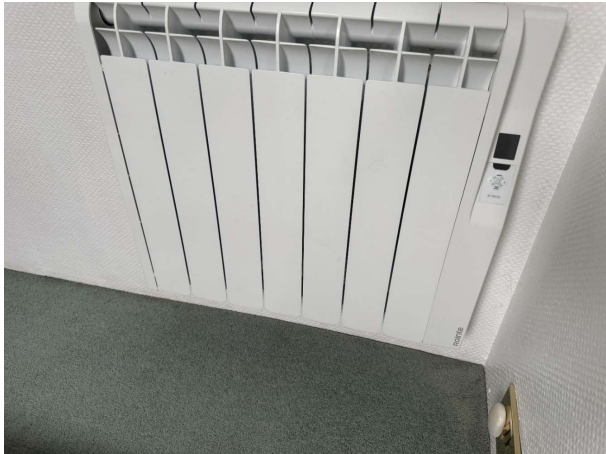
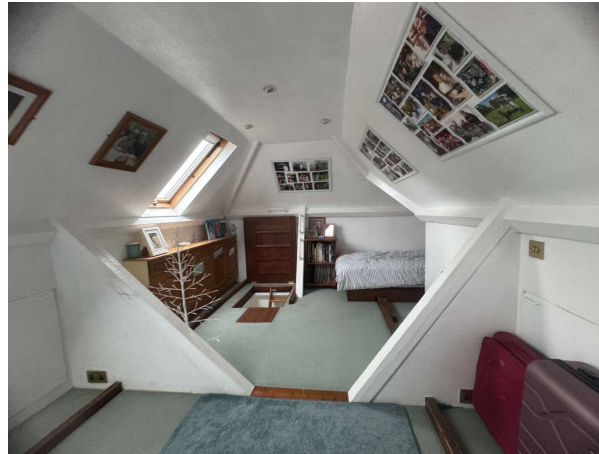
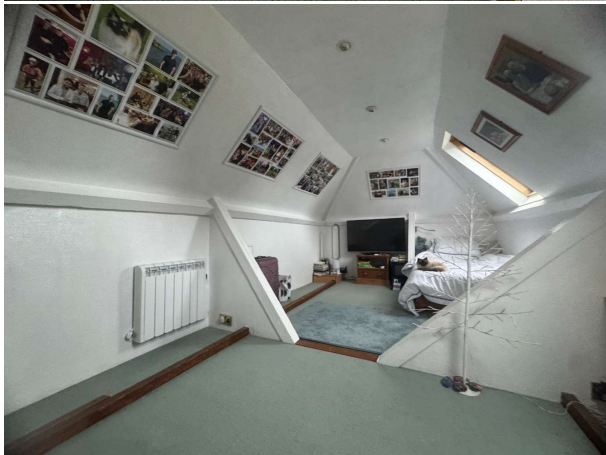
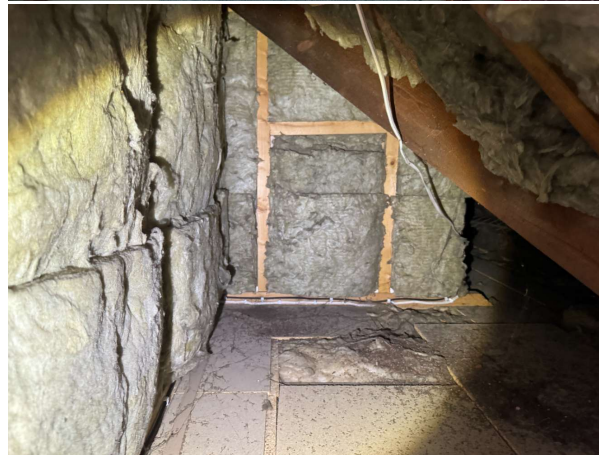
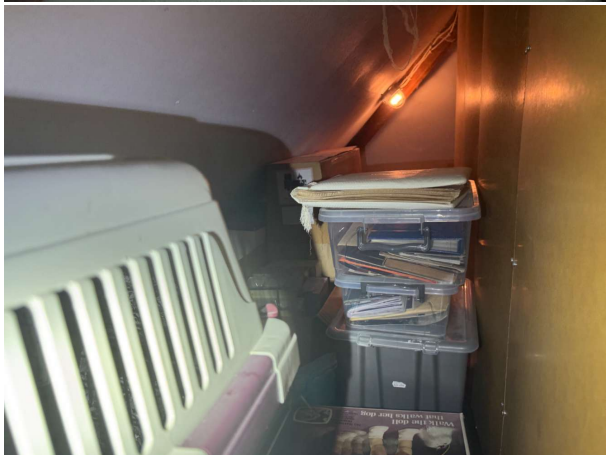
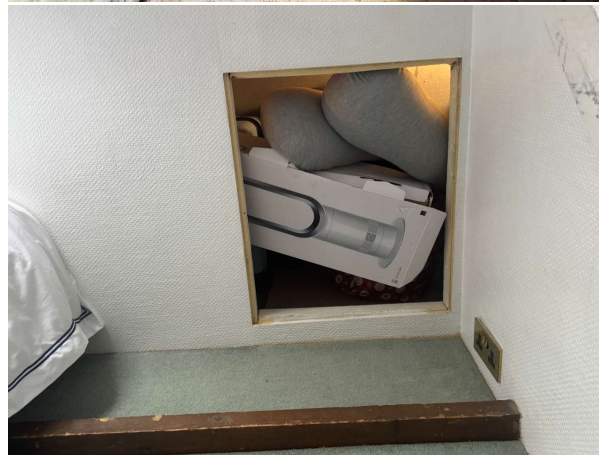
- The attic has been insulated and lined with no evident ventilation. The roof structure is largely concealed, so there is a risk of condensation and timber decay

Instruct a competent roofing contractor, ideally a member of the National Federation of Roofing Contractors (NFRC), to inspect the roof structure, assess the adequacy of the ventilation provision, vapour control and risk of condensation and timber decay and specify any necessary remedial works, which are likely to include the installation of fixed ventilation openings. Obtain a quotation for the necessary remedial works.

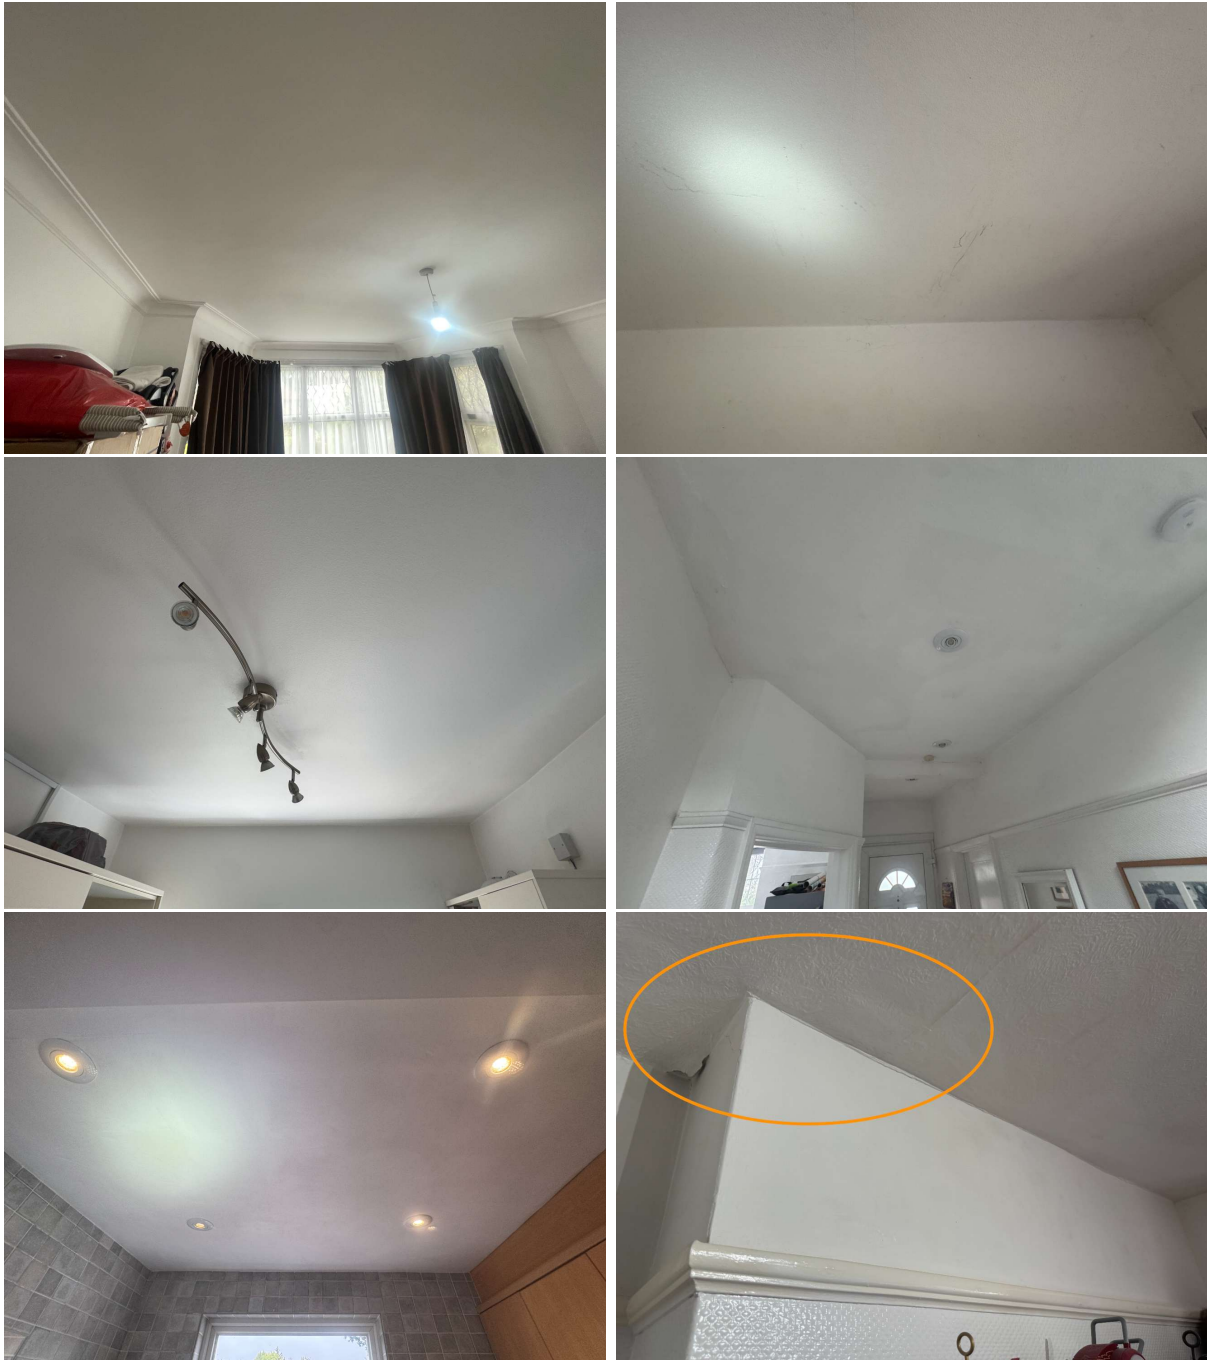
- Elevated moisture meter readings, consistent with a small roof leak, affecting the first-floor bay-fronted bedroom near the redundant chimney breast. The source is unconfirmed. Slipped, cracked and missing tiles and deteriorated hip bedding were also noted

After the external repairs have been completed, closely monitor the ceilings for signs of further leaks to confirm that the source has been resolved. Decorative improvements should only be undertaken once it has been confirmed that no further leaks are present.

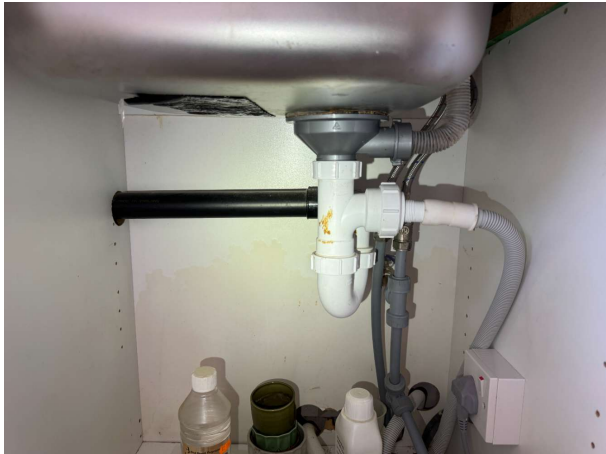
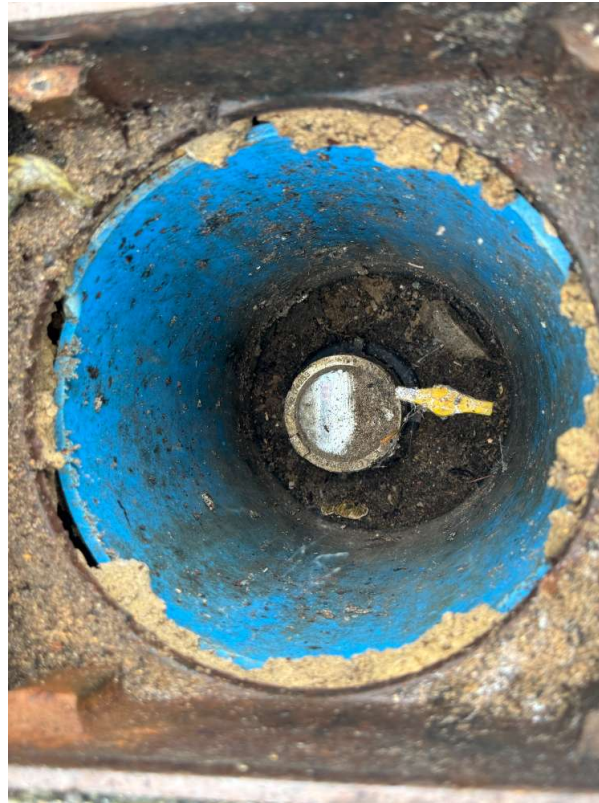
- The condition of the underground drainage is unknown, and the mains water pipe may be lead.

We recommend further investigation to confirm the material of the mains water supply pipe. If the pipework is made of lead, a contractor's quotation should be obtained for its replacement with a modern alternative such as polypropylene.
