# LEVEL 3 BUILDING SURVEY

REPORT PREPARED IN ACCORDANCE WITH THE  
RICS HOME SURVEY STANDARD

Property address:  
**Sample Street, Harrow, HA1 1AH**

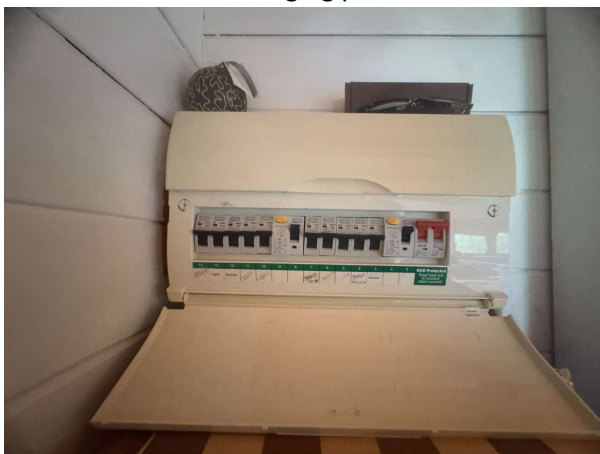
Outbuilding consumer unit

The outbuilding, garden cabin and garage are provided with an electrical connection. This must also be included in the electrical tests.
